CANGREJOS GOLD-COPPER PROJECT, ECUADOR

NI 43-101 Technical Report

Effective Date: September 16, 2016
Execution Date: September 16, 2016

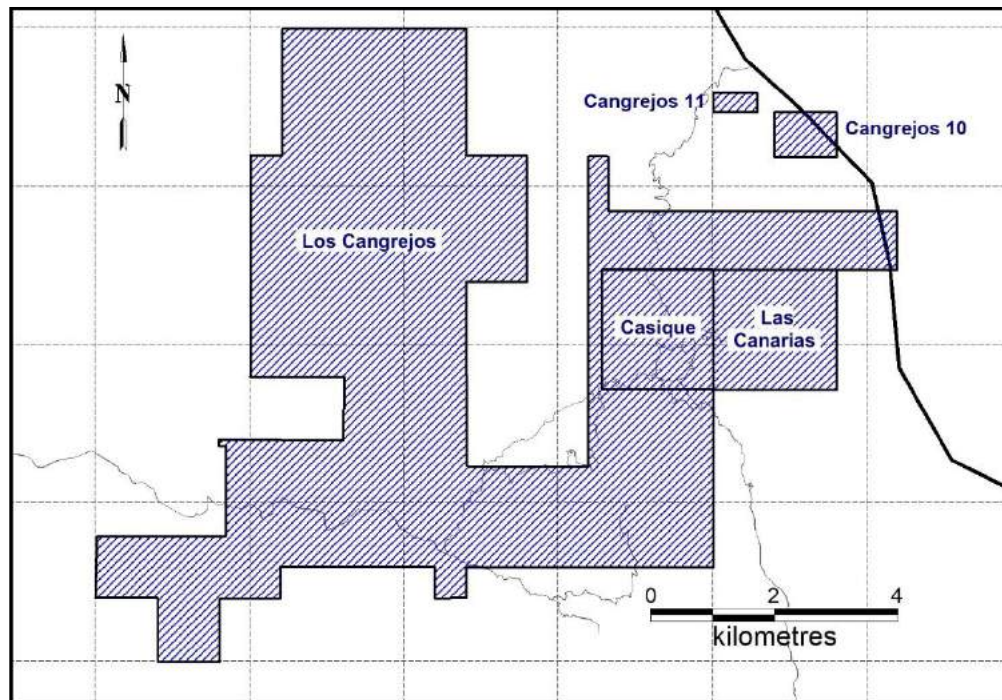
Figure 4-2: Claim Map

The Cangrejos Property consists of five contiguous mining concessions. Concessions are described in Table 4.1 and shown in Figure 4-2.

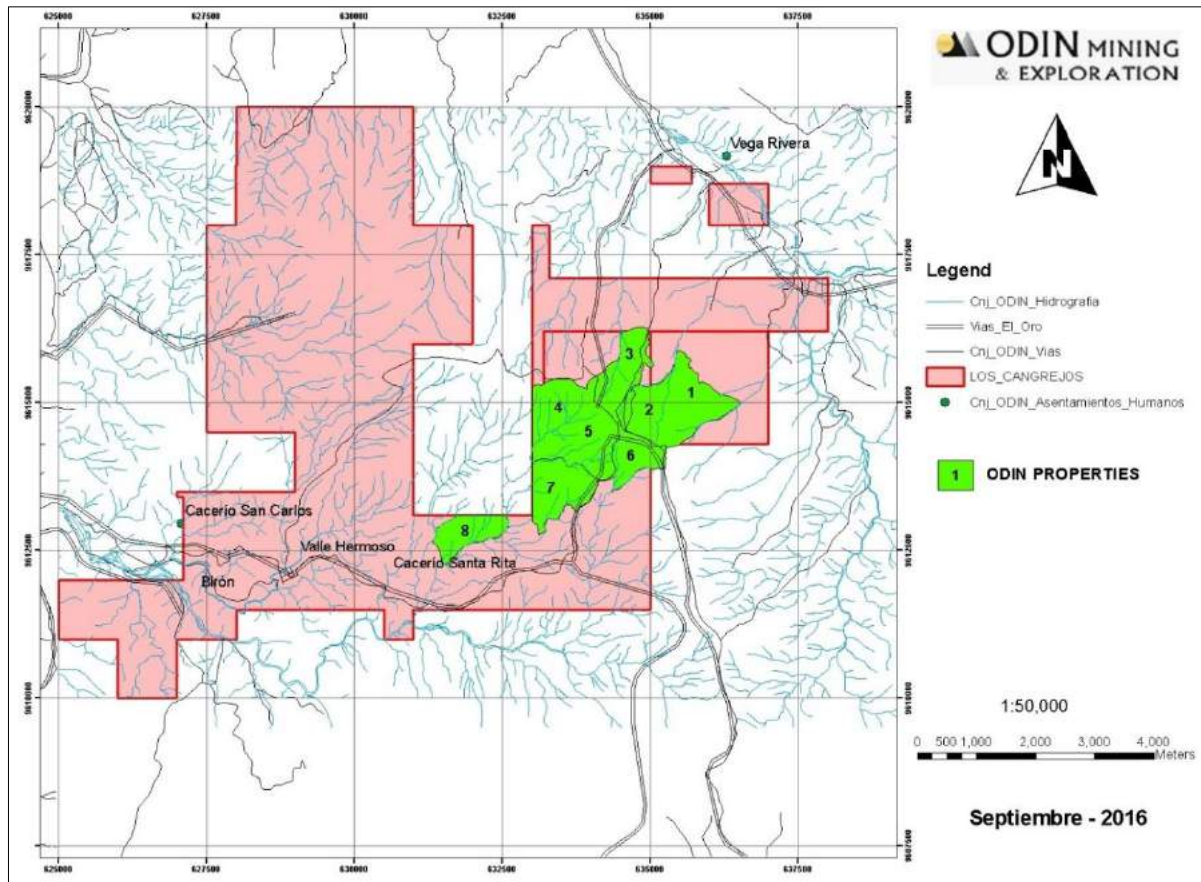
Figure 4-3: Surface Rights

Odin also owns the following surface rights shown in Table 4.2 and Figure 4-3.

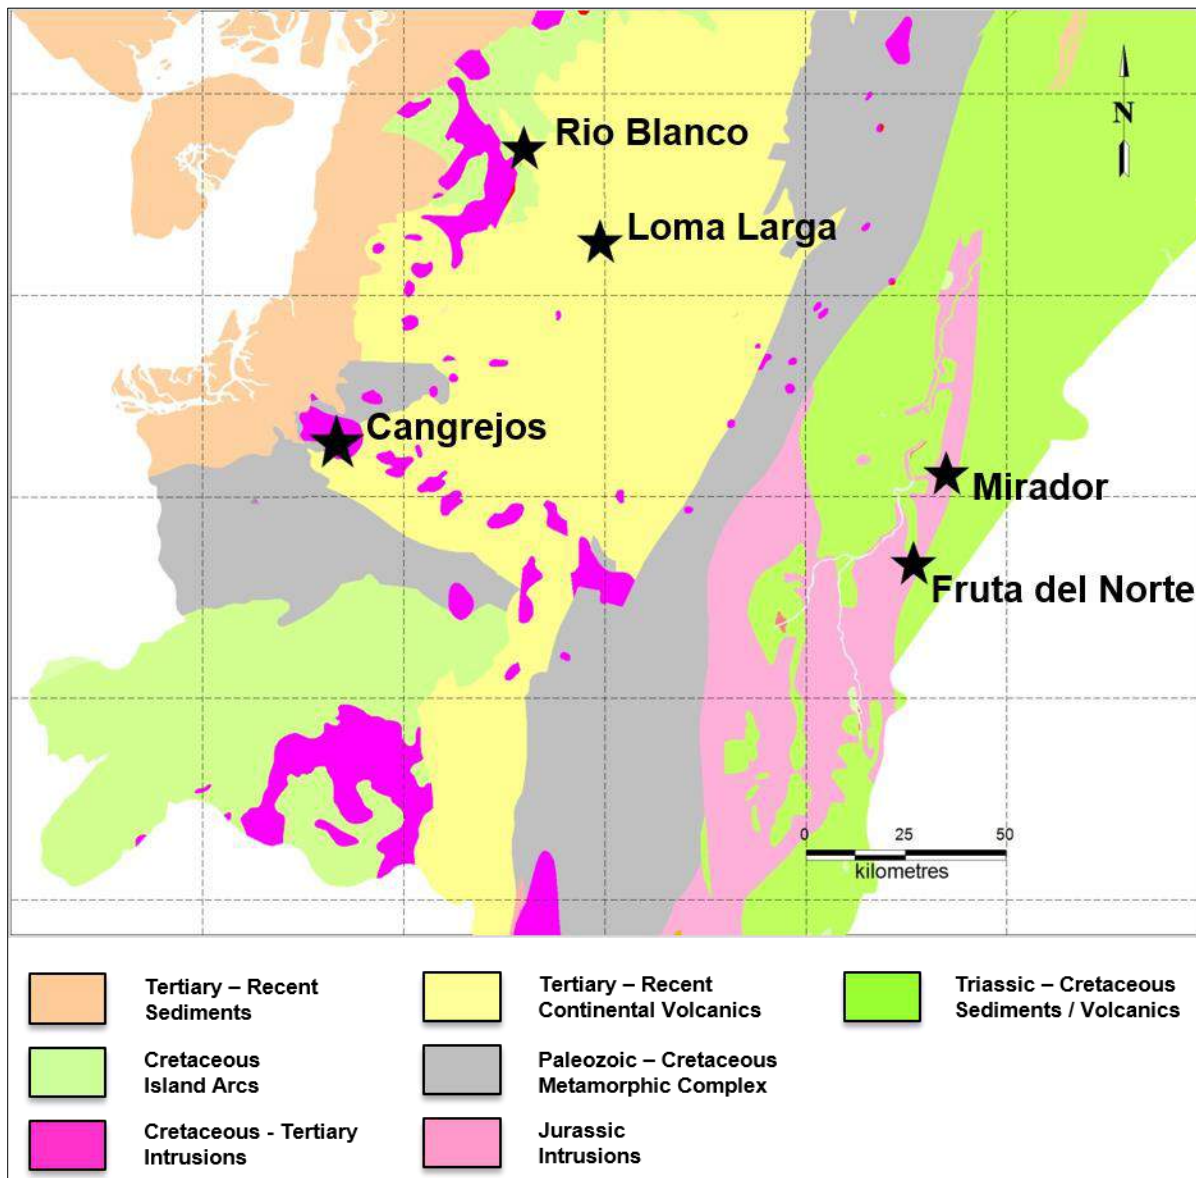
Figure 7-1: Regional Geology

The general geology of southern Ecuador is shown in Figure 7-1. There are several north-south trending domains of volcanics and sediments which accreted onto the Amazon Craton from Late Jurassic to Eocene. These terranes are cut by younger magmatic intrusions which locally host porphyry copper/gold and epithermal gold deposits (shown as black stars in Figure 7-1).

The Cangrejos Project is largely underlain by dioritic to granodioritic intrusions which occur along a west-northwesterly trend (Figure 7-1). These intrusions are Miocene based on K-Ar dates of 16.89 Ma and 19.92 Ma (Potter, 2010). Gold showings occur within the Miocene intrusion and adjacent volcanic and metamorphic rocks.

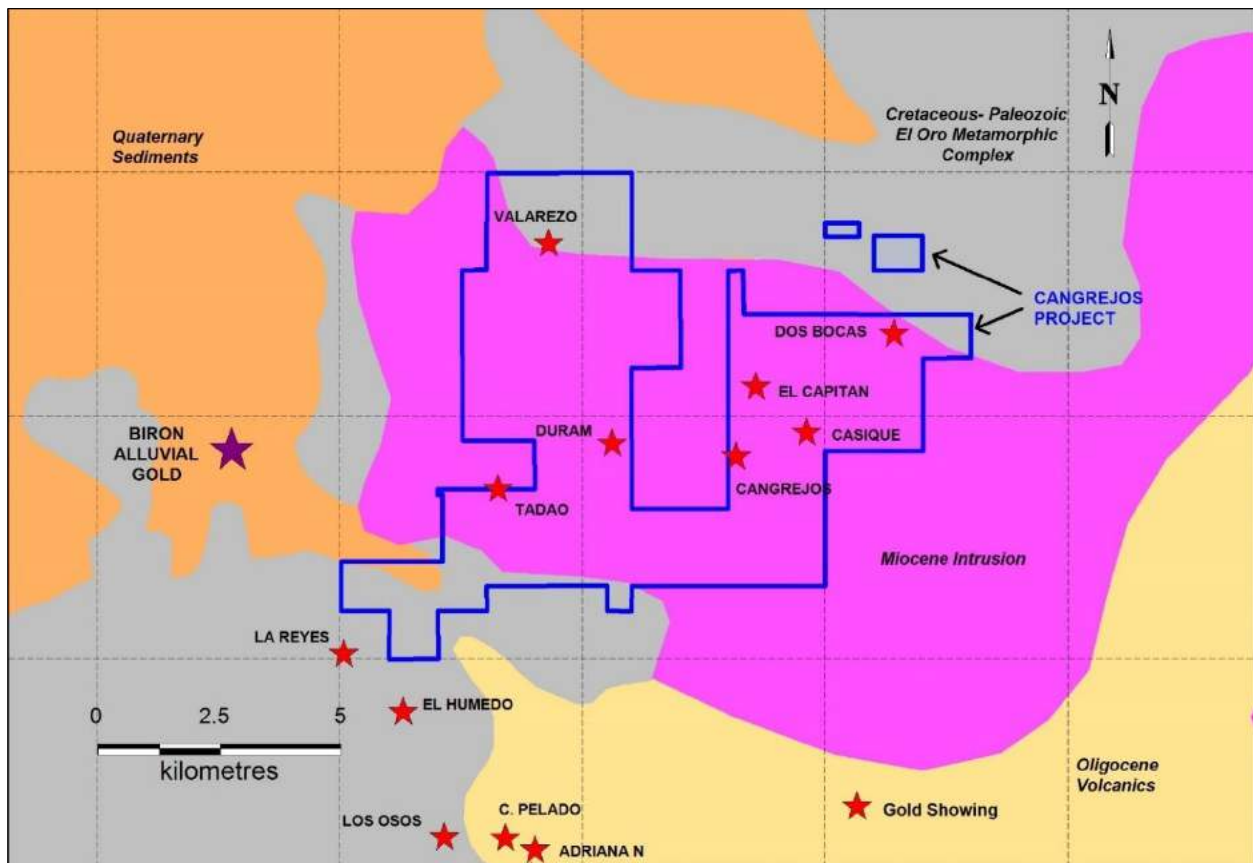
Figure 7-2: Local Geology – Cangrejos Project

A more detailed picture of the geology in the vicinity of the Cangrejos Project is shown in Figure 7-2. Quaternary sediments occur to the northwest in the coastal areas around Machala. Oligocene continental volcanics occur to the east. These two domains are separated by the Late Cretaceous-Paleozoic El Oro metamorphic complex which consists of phyllites, schists, amphibolites, granites and serpentinites.

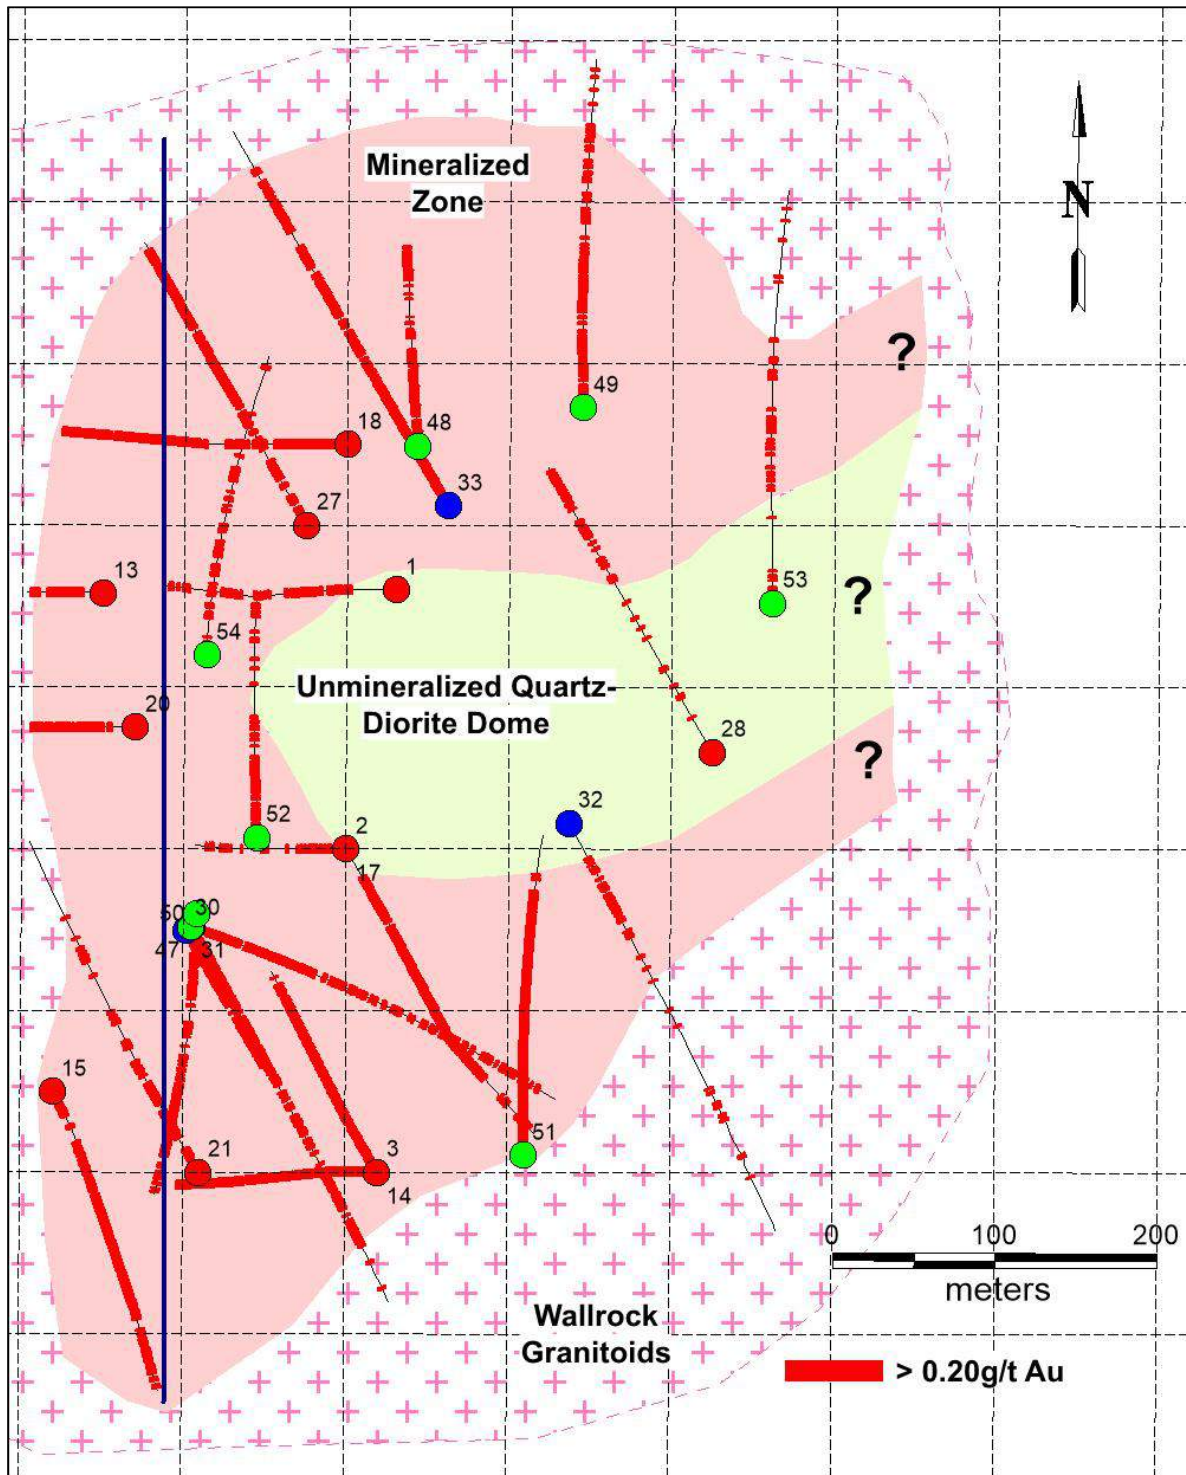
Figure 7-3: Simplified Geology Plan of the Cangrejos Gold-Copper Zone

The surface geology of the Cangrejos Zone is poorly understood due to poor exposures. The simplified geological map and section shown in Figures 7-3 and 7-4 are based primarily on drill hole logs and assays.

Mineralization consists of finely disseminated chalcopyrite-pyrite. Bornite and molybdenite are locally present. Overall sulphide content is low: generally less than 5%.

Note: Newmont (red dots), Odin 2011–2012 (blue dots), Odin 2014–2015 (green dots), North-South Section (Figure 7-4) (blue line).

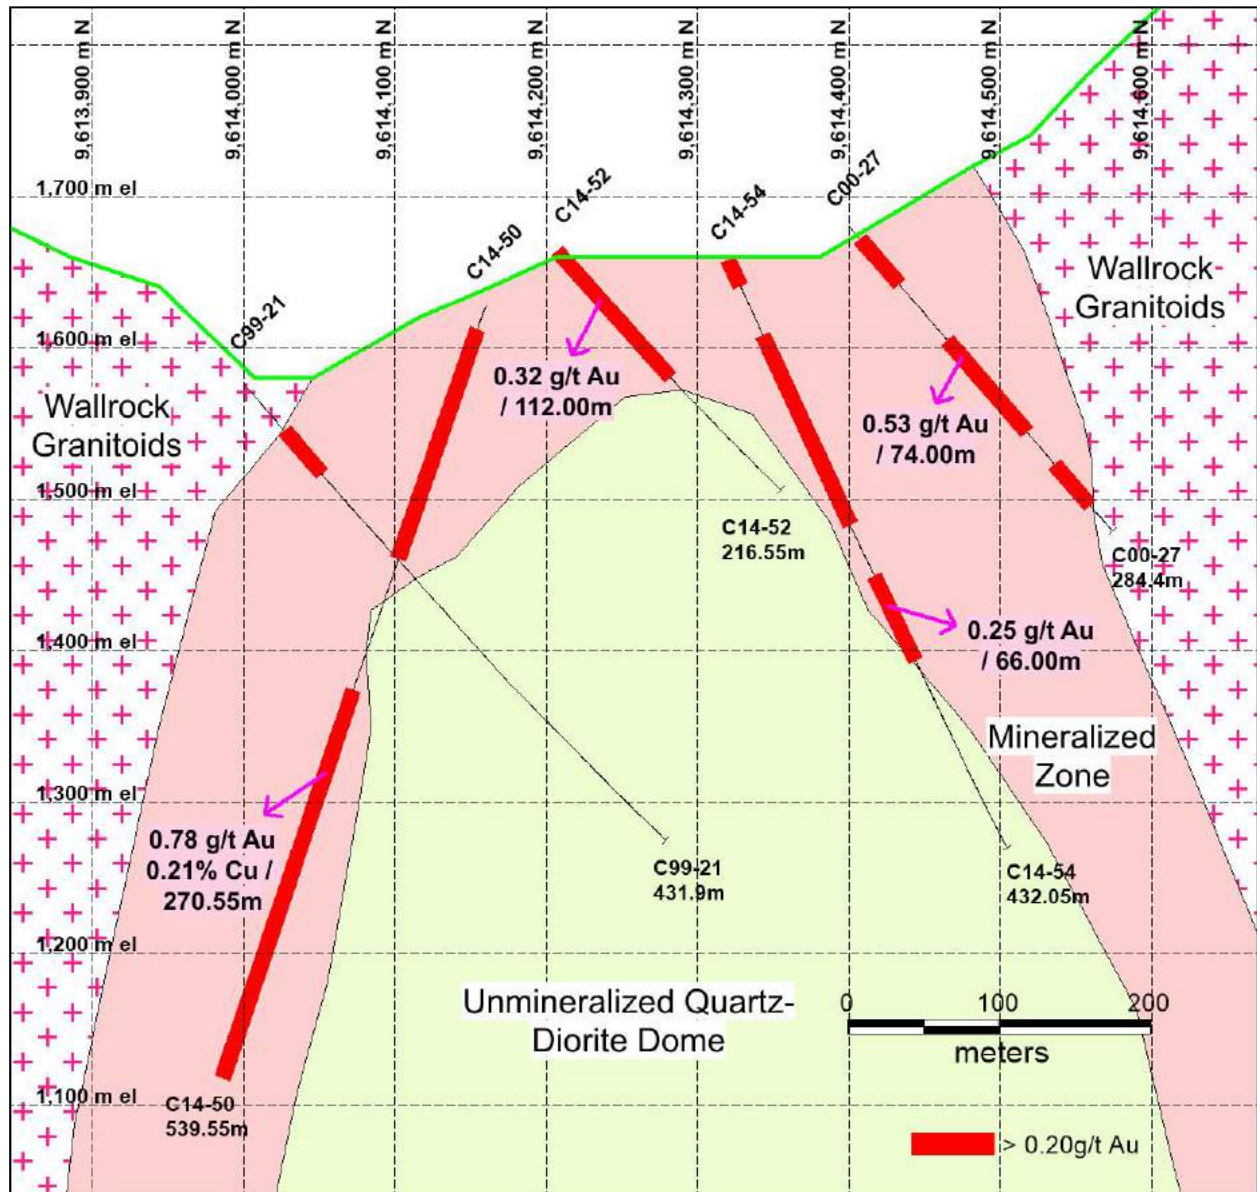
Figure 7-4: Simplified North-South Cross Section – Cangrejos Zone

Note: Assays are over core lengths and not true thicknesses. Additional infill drilling will be required to confirm the orientation of the mineralized zones.

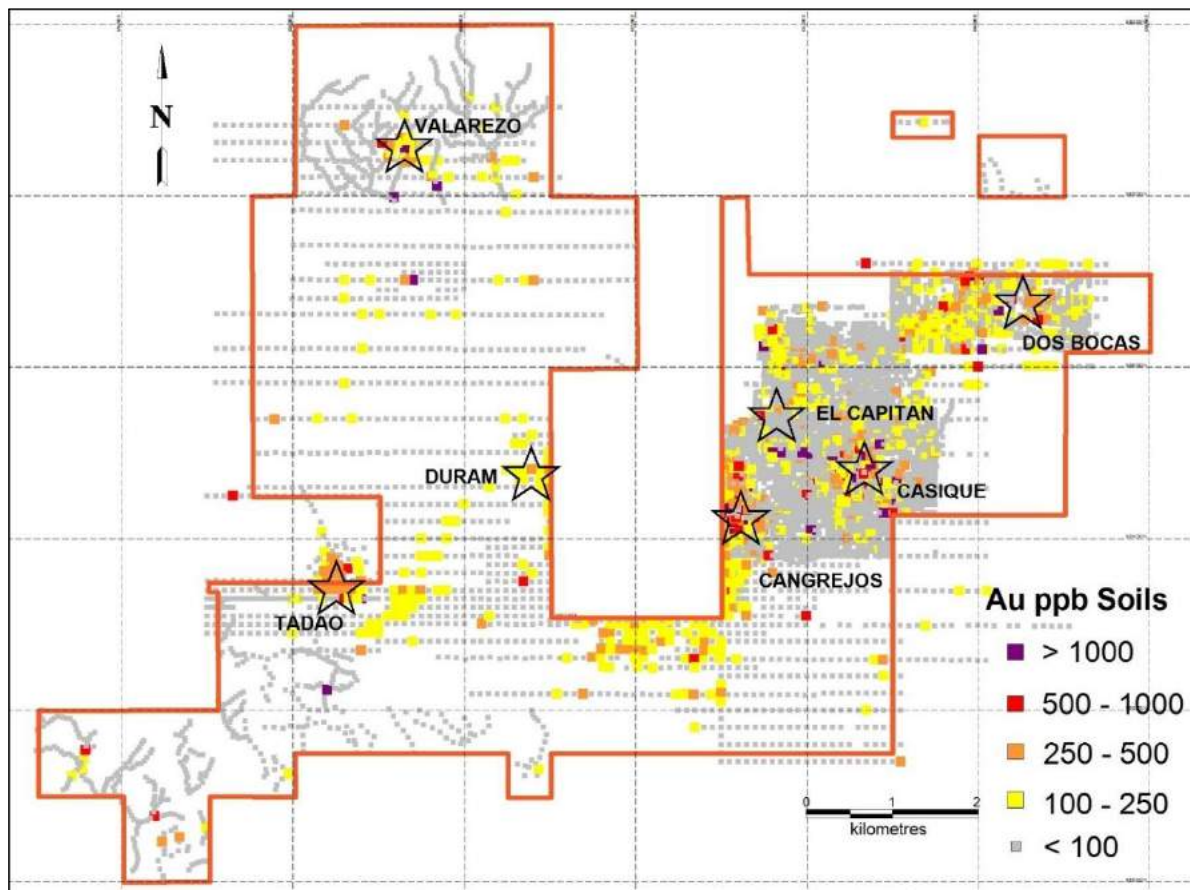
Figure 9-1: Soil Geochemistry - Gold

The property has seen extensive geochemical surveys (streams, soils, top of bedrock soils and rocks). Well-defined gold and/or copper anomalies have been defined and are shown in Figures 9-1 and 9-2. The best defined geochemical anomaly is associated with the Cangrejos mineralized zone, and this is where most of the drilling has been done.

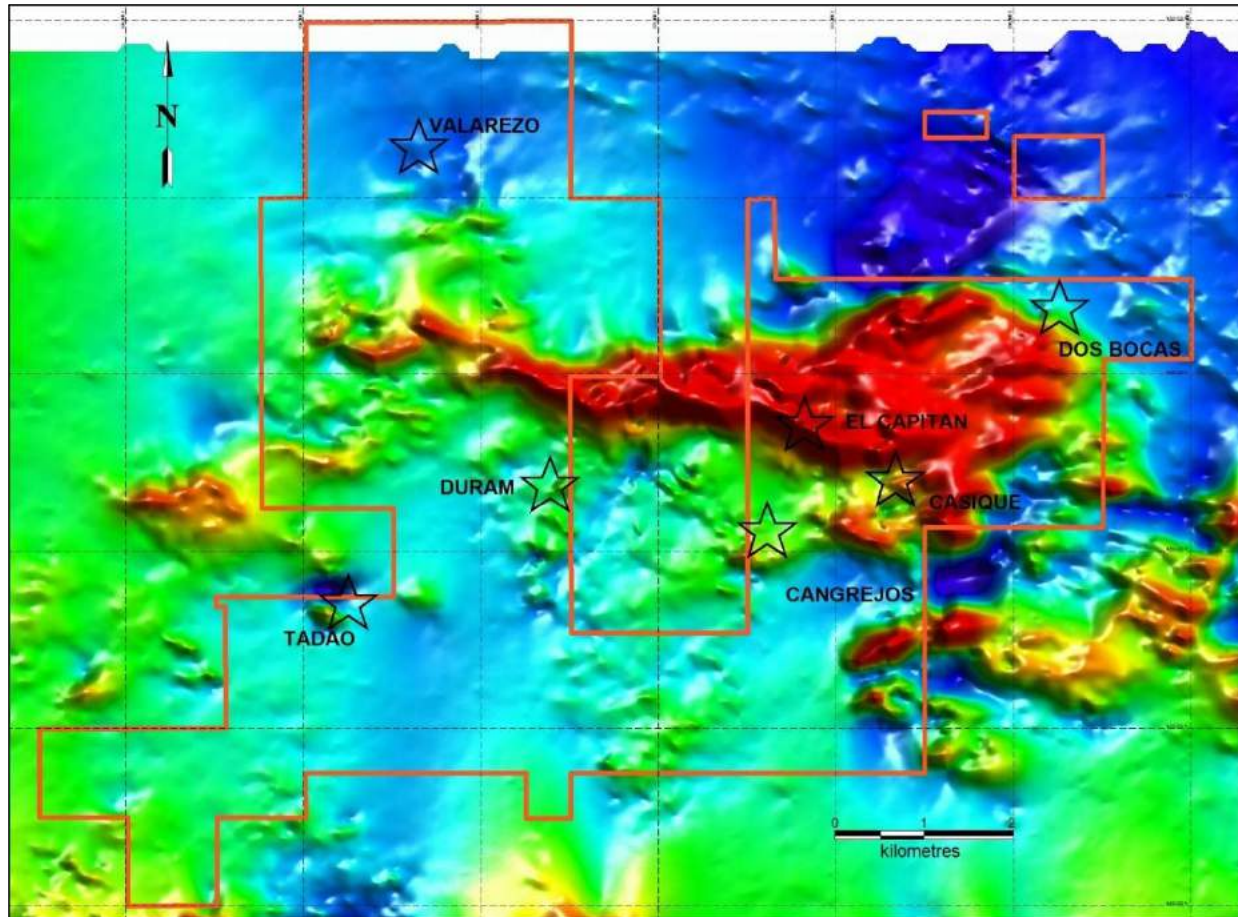
Figure 9-3: Exploration Targets – Cangrejos Project, RTP Magnetics

The airborne magnetic survey was used to help define structures. In addition, small circular magnetic highs are interpreted as breccia pipes. Several of these have gold geochemical anomalies. The location of these exploration targets are shown in Figure 9-3 and described in Table 9.1.

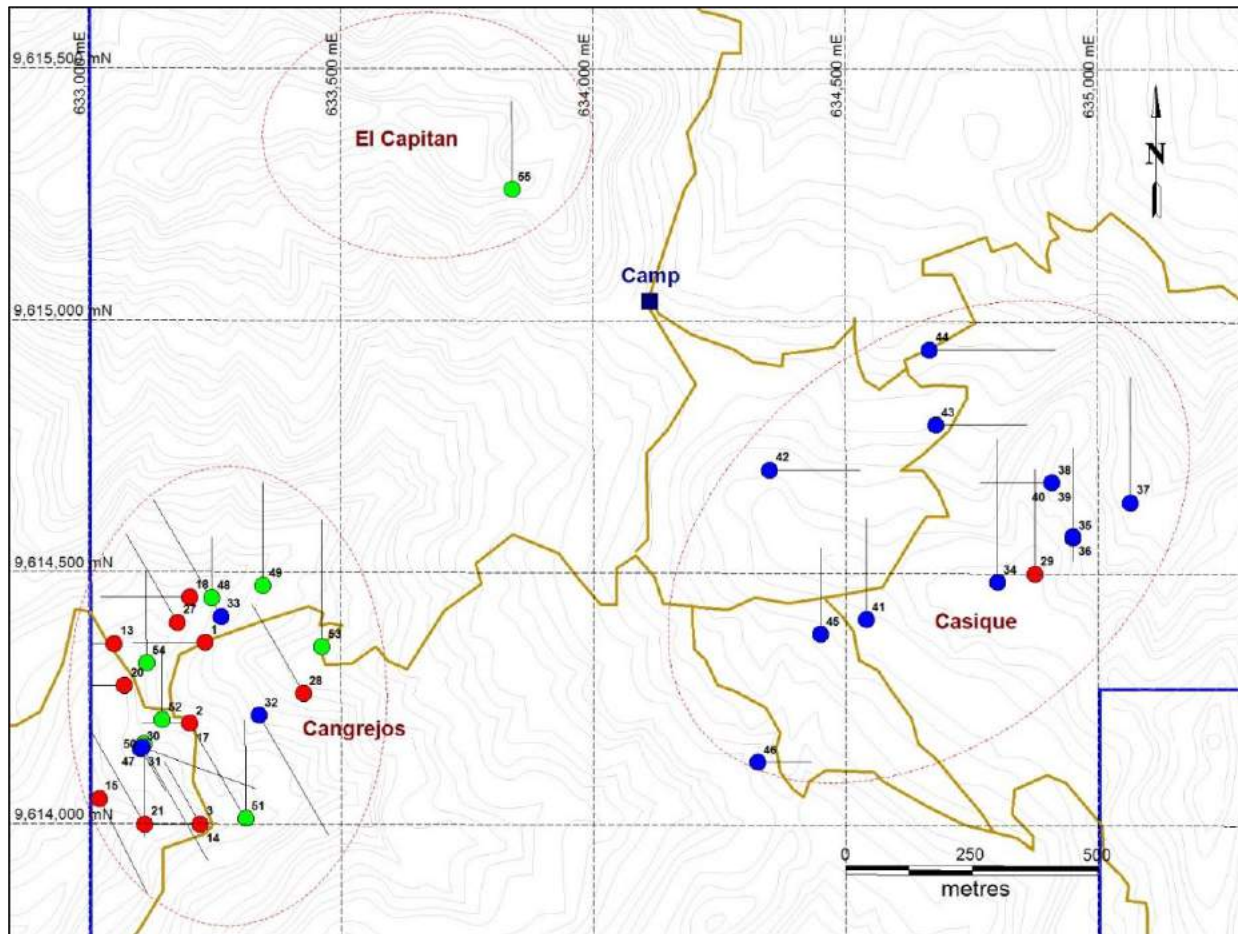
Figure 10-1: Drill Collar Plan Map – Cangrejos Project

Drilling completed on the project is shown in Figure 10-1. Collar information, mineralized zone and operator are shown in Table 10.1. Holes have been located using handheld GPS units.

Note: Newmont (red dots), Odin 2011–2012 (blue dots), Odin 2014–2015 (green dots), drill roads (brown lines).
